Home Inspection Report

58 Pine St, Bristol , Vermont 05443

Friday, March 26, 2021

Champlain Valley Home Inspection LLC

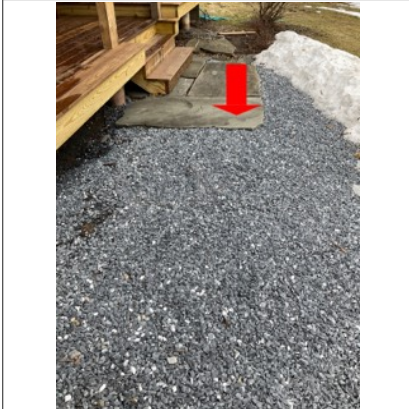
Walkway is under construction.
Trip hazard located at red arrow

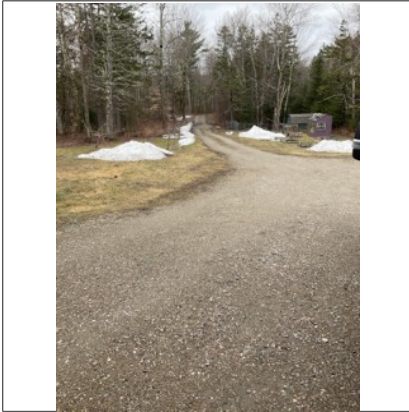
Comments Driveway had some settlement, but usable, recommend repair

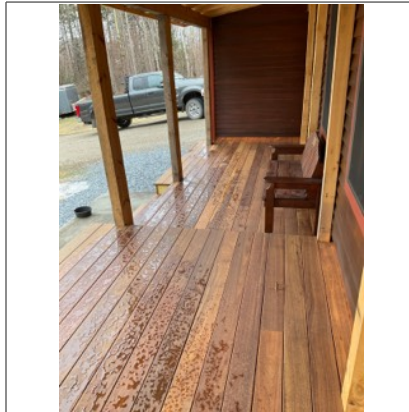
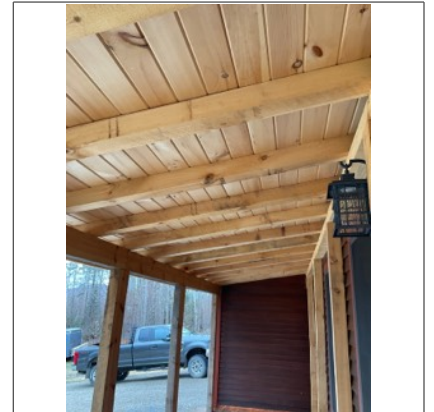
☐ None ☐ Not Visible
Condition ☒ Satisfactory ☐ Marginal ☐ Poor ☒ Railing/Balusters recommended
Support Pier ☐ Concrete ☒ Wood Other: _____
Floor ☒ Satisfactory ☐ Marginal ☐ Poor ☐ Safety Hazard
Comments Porch/deck missing railings, recommend installing proper guardrails

There is more then 30 inches from decking to ground which requires a railing guard.

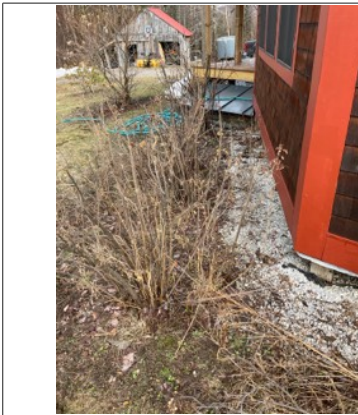
Comments Some shrubs are against house. Recommend trimming back

Bushes are at least 12" from house but a few stragglers are against siding. Recommend pruning away from house

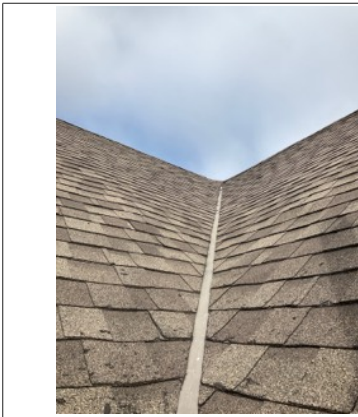
Valley of main roof.
Some granular missing from
weather

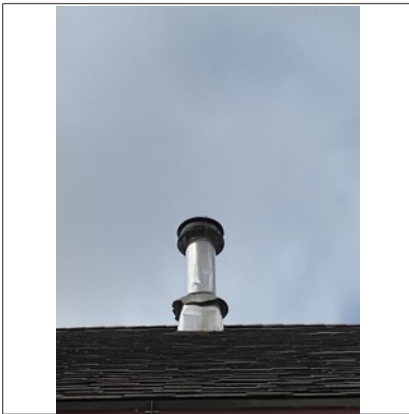
Comments Chimney has a few small dents.

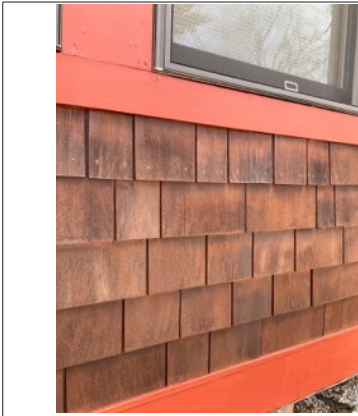
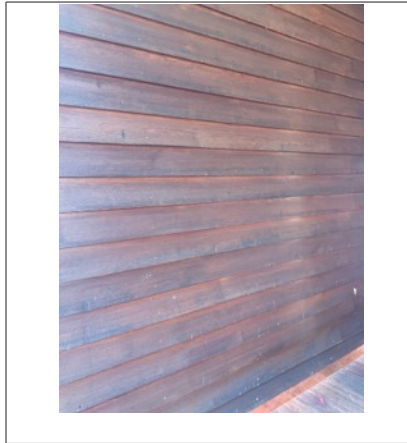
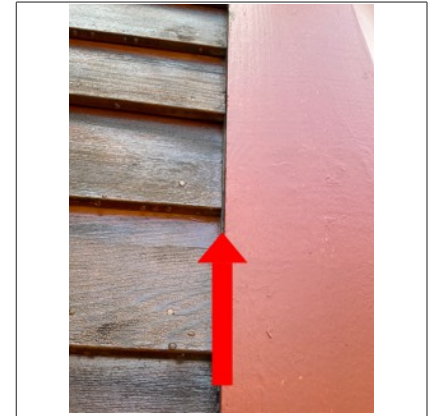
Comments Recommend caulking/sealing where siding meets corner trim and windows

Caulking/sealing recommend

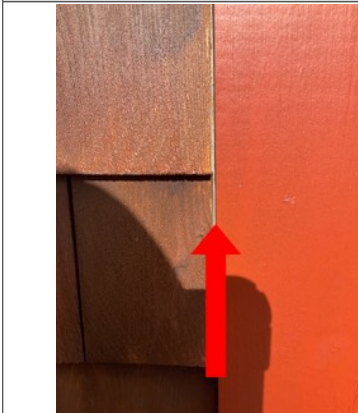
Caulking/sealing recommended

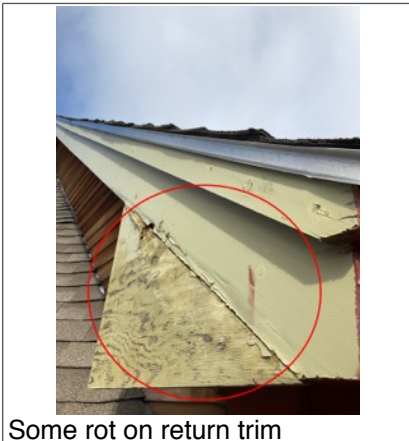
Comments Recommend repair on trim on east gable return.

Some rot on return trim

Recommend repair of damaged trim by a qualified contractor

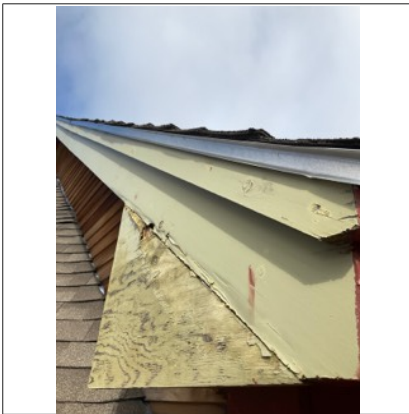
Over all satisfactory. One spot on east side gable needs attention
Fascia rotted/damaged, recommend repair

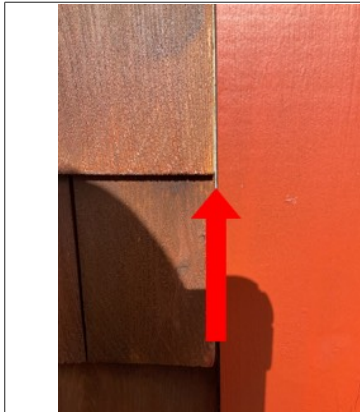
Recommend caulking

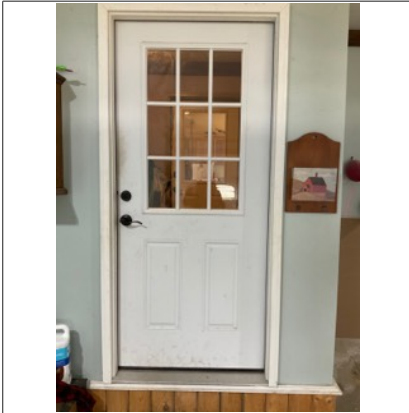
Comments Entrance door from garage to kitchen needs to be a fire rated door
Recommend proper fire-rated door between garage and house with self closure.

Not a fire rated door

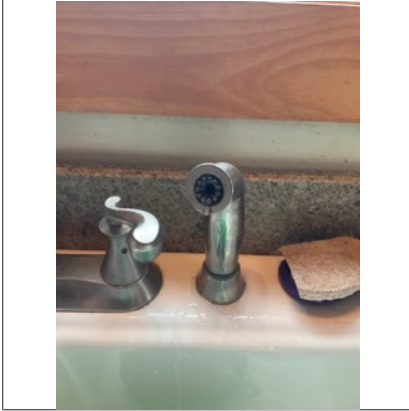
Comments Water flow was normal with several fixtures operated at the same time.
Noticed the kitchen faucets spray wand is dripping

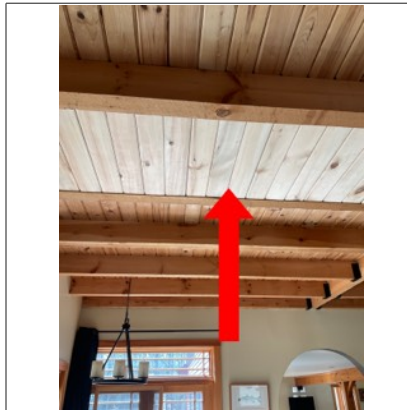
Comments Some shrinkage cracks where wood beams contact Sheetrock on wall

Wood beams have shrunk from drying. Crack is visible where Sheetrock and beam meet

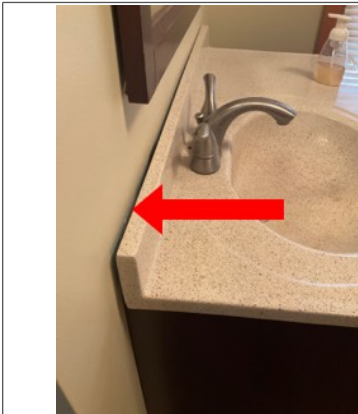
Sink is not securely attached to vanity cabinet
 Recommend G.F.C.I outlets within 5 feet of a water source
 Laundry is also located in this bathroom.

Sink is loose not attached to base cabinet.

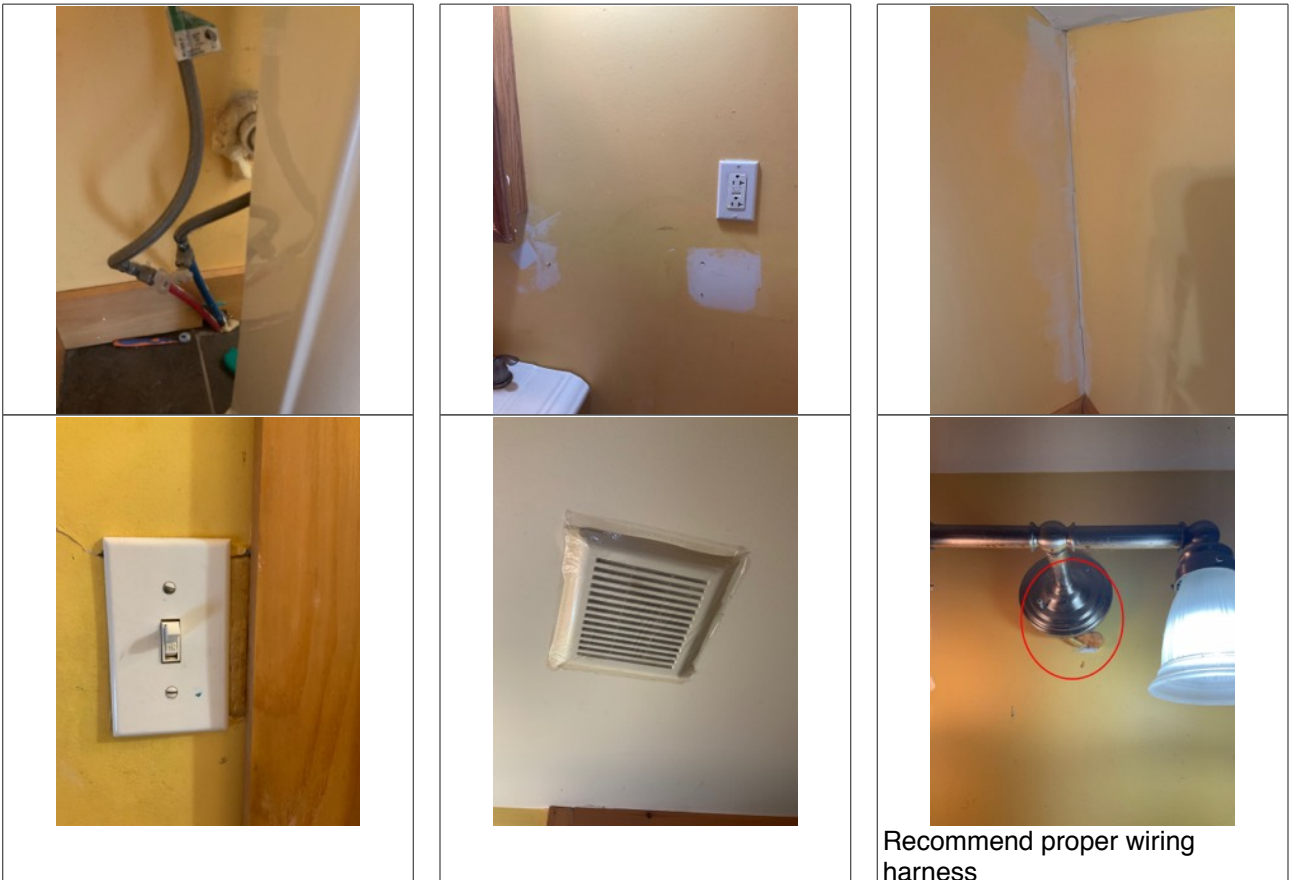
Comments Bathroom needs wall patching and paint
 Recommend a plumber to evaluate water line distribution covers
 Not professionally installed water distribution lines
 Door hits sink when opening.
 Recommend electrician for proper wiring harness above vanity cabinet
 Bathroom exhaust vent has plastic over it. Inoperable.

Recommend grouting

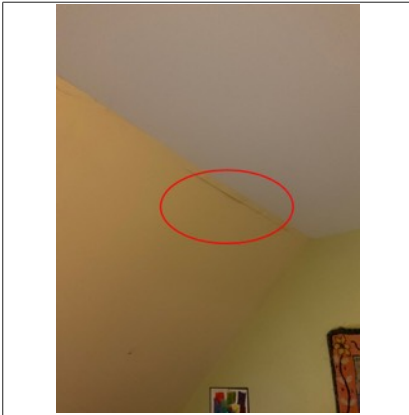
Comments Typical cracks.
Surface deterioration apparent. Mud/tape repair
Not many pictures due to personal belongings

Sheetrock tape is peeling.
Recommend mud/paint

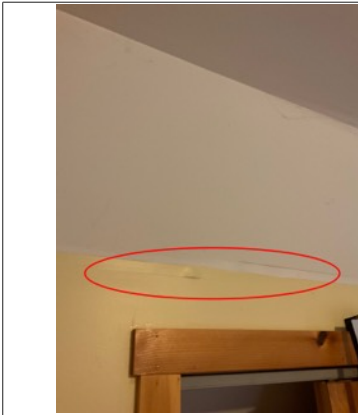
Sheetrock tape has peeled from surface.
Recommend mud/tape paint

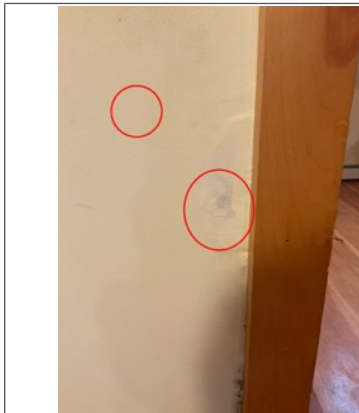
Nail pops. Needs paint

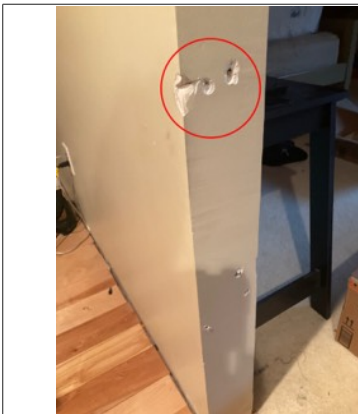
Mud/paint repair

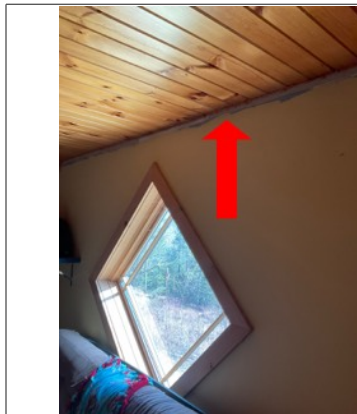
Needs finish trim

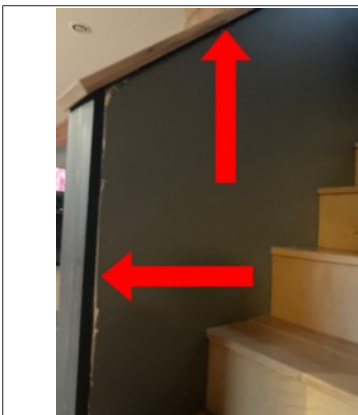
Condition ☒ Satisfactory ☐ Marginal ☐ Poor ☐ Loose/Missing
Handrail ☒ Satisfactory ☐ Marginal ☐ Poor ☐ Safety hazard ☐ Hand Rail/Railing/Balusters recommended
Risers/Treads ☒ Satisfactory ☐ Marginal ☐ Poor ☐ Risers/Treads uneven ☐ Trip hazard
Comments Needs finish Sheetrock mud/tape in stairwell

Small gap. Needs finishing.

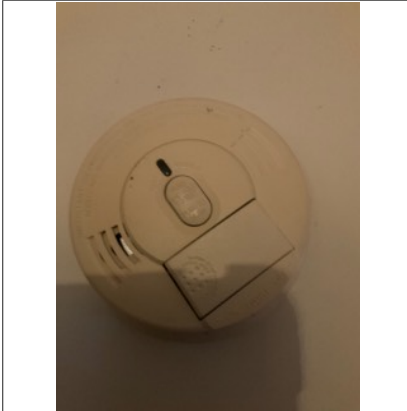
Found one alarm that is past it's life time. Located in living room
 Recommend replacement. Has yellowing color.

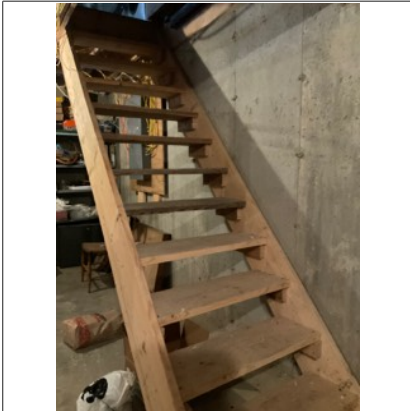
Handrail missing, potential safety issue. Recommend Installing handrail

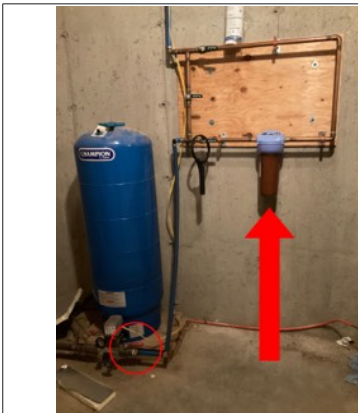
Main water shut off is circled in red.
 Arrow points to the whole house water filter, recommend changing filter.

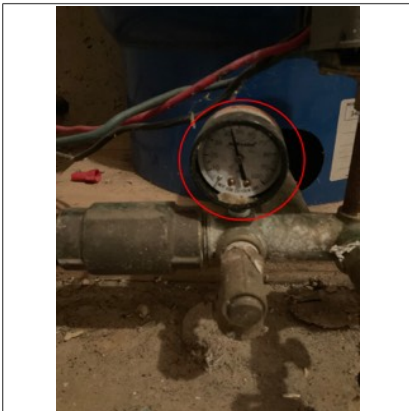
Protective glass is Broken on gauge. Circled in red.

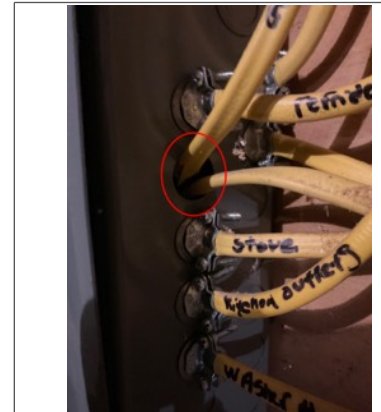
Recommend entrance to panel clamp
