Home Inspection Report

58 Pine St, Bristol , Vermont 05443

Friday, March 26, 2021

Champlain Valley Home Inspection LLC

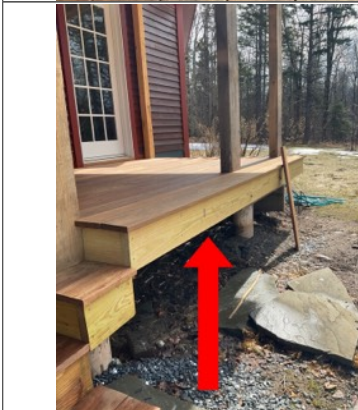
☐ None ☐ Not Visible
Condition ☒ Satisfactory ☐ Marginal ☐ Poor ☒ Railing/Balusters recommended
Support Pier ☐ Concrete ☒ Wood Other: _____
Floor ☒ Satisfactory ☐ Marginal ☐ Poor ☐ Safety Hazard
Comments Porch/deck missing railings, recommend installing proper guardrails

There is more then 30 inches from decking to ground which requires a railing guard.

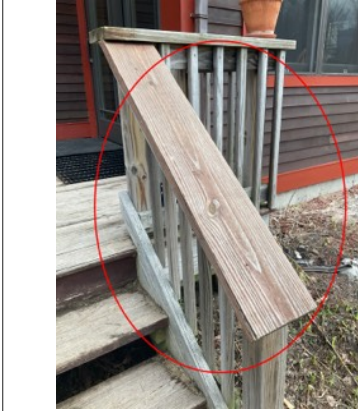
Railing is not graspable.
Recommend installing proper railing. Red circle.

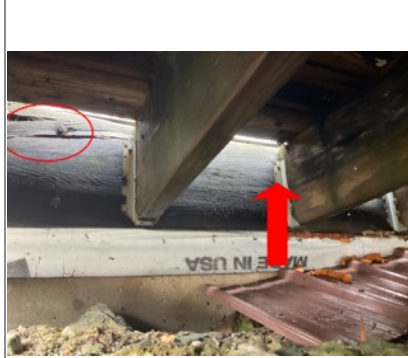
Ledger board is not attached properly to house.(circle)
Not all nails in joist hangers are applied.(arrow)

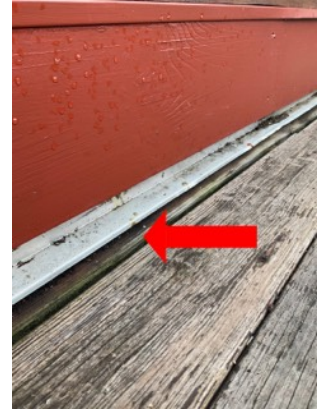
Back deck is pulling off of house. Needs repair. See photos on deck section

Ledger of the deck has pulled off the house and has dropped down about 1 inch.

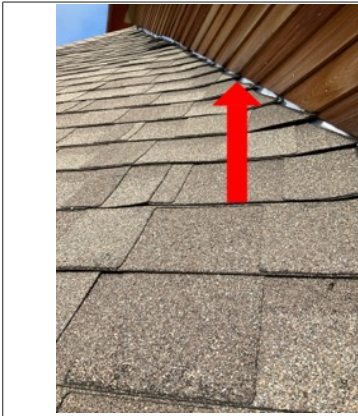
Comments It is required to have exposed flashing at least two inches above roof covering. Flashing does not meet this stand requirement.

Standard requirement of two inches of space not met. Red arrow points to where the minimum distance of two inches should be.

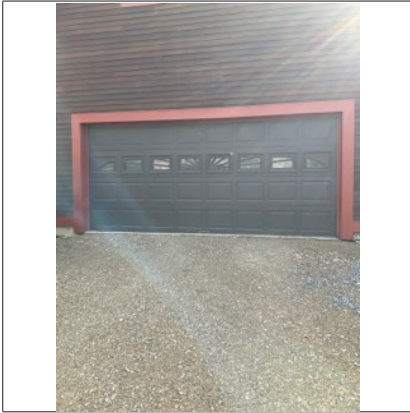
Material ☐ N/A ☐ Wood ☒ Fiberglass ☐ Masonite ☐ Metal ☐ Recommend repair
Condition ☒ Satisfactory ☐ Marginal ☐ Poor ☐ Hardware loose ☐ Safety Cable Recommended
☐ Weatherstripping missing/damaged ☐ Loose/missing
Recommend Priming/Painting Inside & Edges ☐ Yes ☒ No
Comments Garage door and opener is in normal working order at time of the inspection.

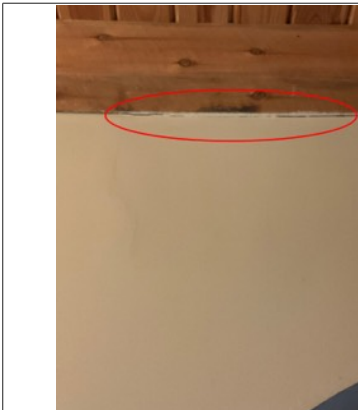
Comments Some shrinkage cracks where wood beams contact Sheetrock on wall

Wood beams have shrunk from drying. Crack is visible where Sheetrock and beam meet

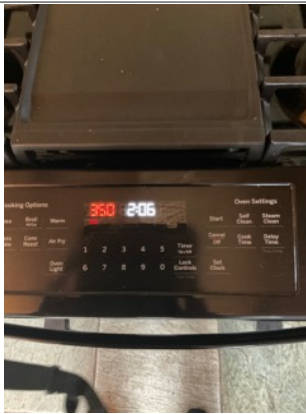
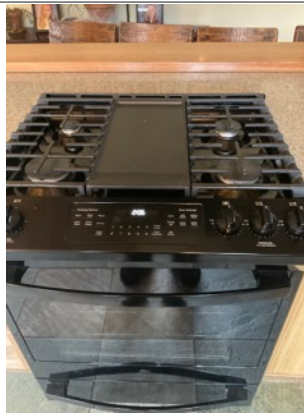
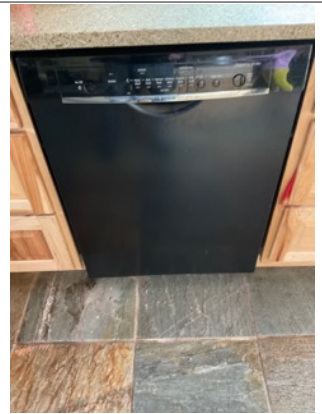
Comments Picture indicates turning oven on and testing oven, broiler and top burners. Then turning back off

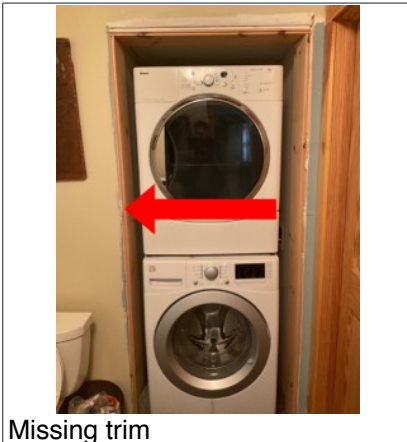
Laundry sink ☒ N/A
Faucet leaks ☐ Yes ☒ No
Pipes leak ☐ Yes ☒ No ☐ Not Visible
Cross connections ☐ Yes ☒ No ☐ Potential Safety Hazard
Heat source present ☒ Yes ☐ No
Room vented ☒ Yes ☐ No
Dryer vented ☐ N/A ☒ Wall ☐ Ceiling ☐ Floor ☐ Not vented ☐ Plastic dryer vent not recommended
☐ Not vented to exterior ☐ Recommend repair ☐ Safety hazard
Electrical Open ground/reverse polarity: ☐ Yes ☒ No ☐ Safety hazard
GFCI present ☐ Yes ☒ No Operable: ☐ Yes ☐ No ☒ Recommend GFCI Receptacles
Appliances ☒ Washer ☒ Dryer ☐ Water heater ☐ Furnace/Boiler
Washer hook-up lines/valves ☐ Satisfactory ☐ Leaking ☐ Corroded ☒ Not Visible
Comments Washer/dryer is located in downstairs bathroom.
 Missing trim around framing of washer/dryer
 Recommend G.F.C.I receptacles in bathroom where laundry is located.

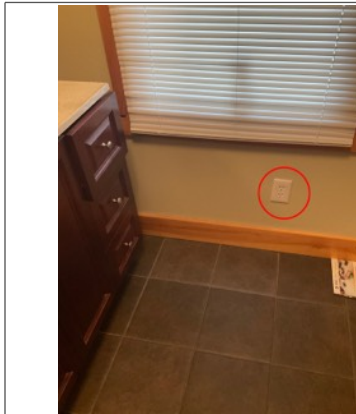
Recommend G.F.C.I. Red circle

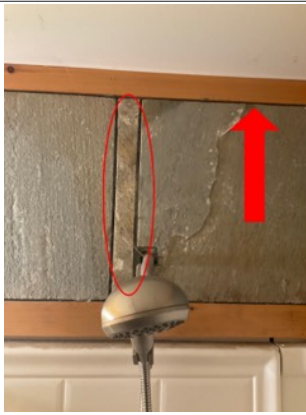
Recommend grouting

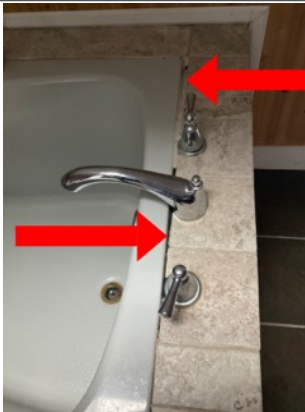
Grouting recommended

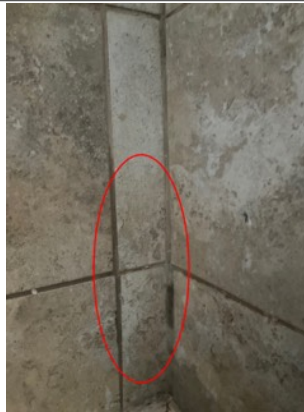
Recommend sealing grout and repair missing grout

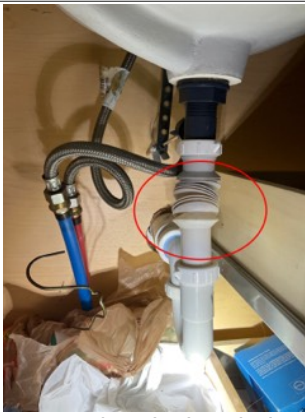
Recommend replacing drain connector. Flexible drain is not adequate drain

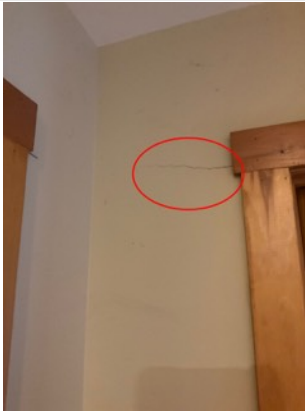
Settling around doors is common.
The wall is not a structure load bearing wall. Seems to have a settlement crack.

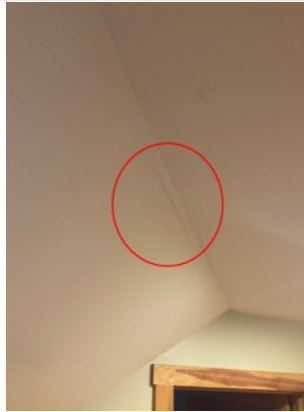
Sheetrock tape is peeling.
Recommend repair/paint

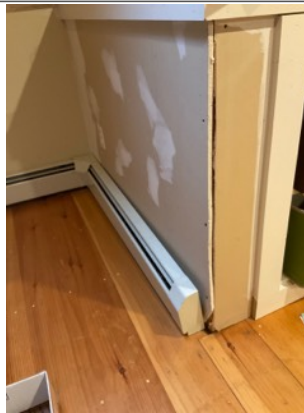
Unfinished portion

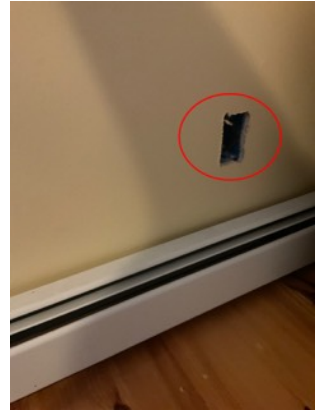
Cable/phone outlet missing cover

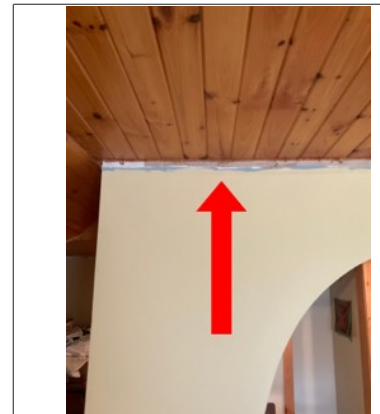
Needs finish trim

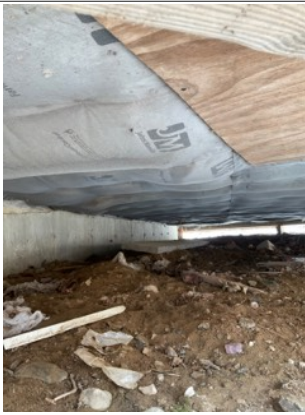
Outside underneath of sunroom

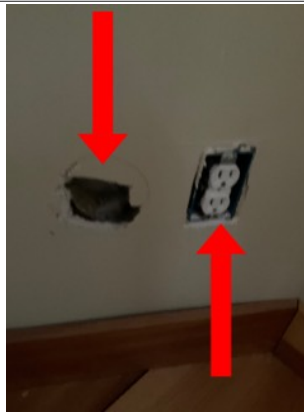
Outlet receptacle plate cover is missing
Hole in the wall needs patching and finish paint

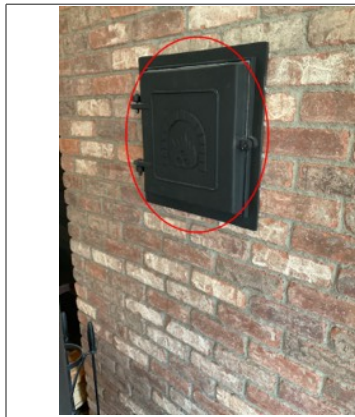
Stove ash clean out

Location(s) Living room
Type ☐ Gas ☒ Wood ☐ Solid fuel burning stove ☐ Electric ☐ Ventless
Material ☐ Masonry ☐ Metal (pre-fabricated) ☐ Metal insert ☒ Cast Iron
Miscellaneous ☒ Blower built-in Operable: ☒ Yes ☐ No Damper operable: ☒ Yes ☐ No
☐ Open joints or cracks in firebrick/panels should be sealed ☐ Fireplace doors need repair
Hearth extension adequate ☒ Yes ☐ No
Mantel ☐ N/A ☒ Secure ☐ Loose ☐ Recommend repair/replace
Physical condition ☒ Satisfactory ☐ Marginal ☐ Poor ☐ Recommend having flue cleaned and re-examined
☐ Not evaluated
Comments Access to clean out is on brick veneer. cast iron door opens
 Recommend cleaning chimney pipe at least once a year.

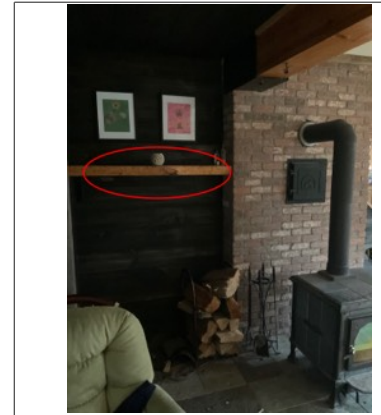
Pine mantelpiece, secure and in good shape

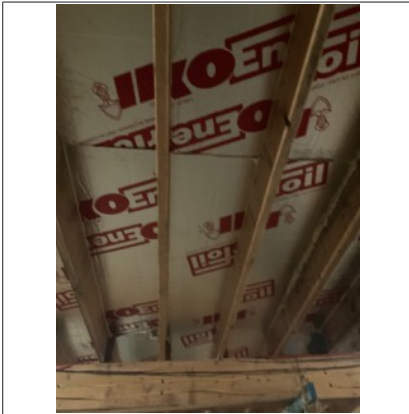
Foam insulation installed between
floor Joyce.
Sub floor is not visible

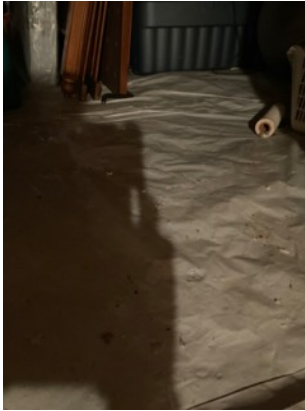
Vapor barrier is in good condition,
sealed, and no holes

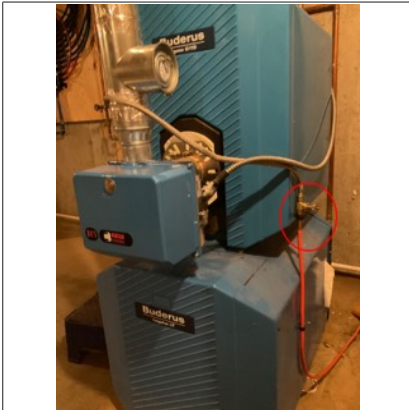
Main fuel shut off is circled in red.
